Salt Spray Test Report

FFI Stainless Steel Lift Slide Comparative

A 3000 hour analysis of lift slide door hardware from various manufacturers

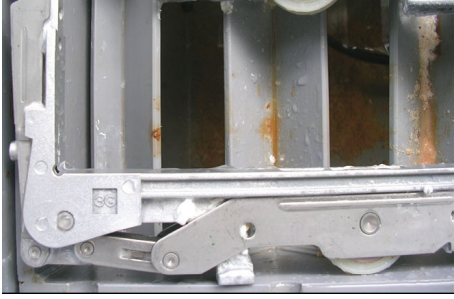
CARRIAGE

BODY	Minor corrosion
BAR	No corrosion
BEARING	Minor corrosion
OPERATION	No problem

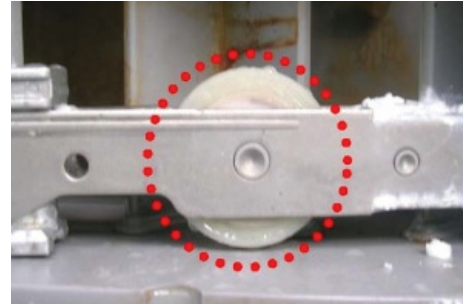
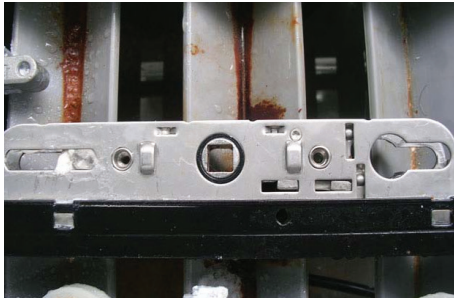
DRIVE GEAR

GEAR BOX	Minor corrosion
LINKAGE	SST Flat linkrod/Pin Fail-proof
AL SASH	No corrosion
OPERATION	No problem

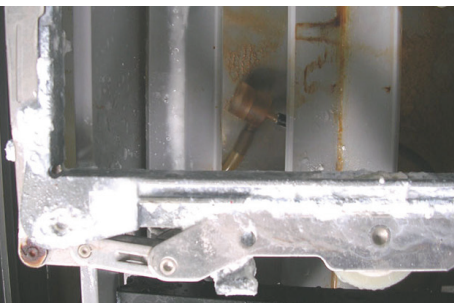
CARRIAGE

BODY	Minor corrosion
BAR	No corrosion
BEARING	Minor corrosion
OPERATION	No problem

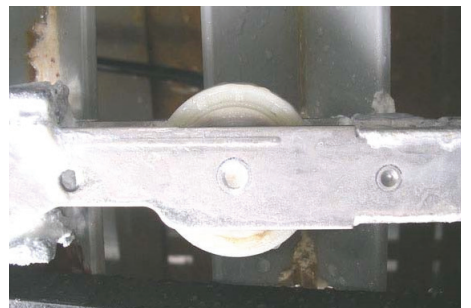
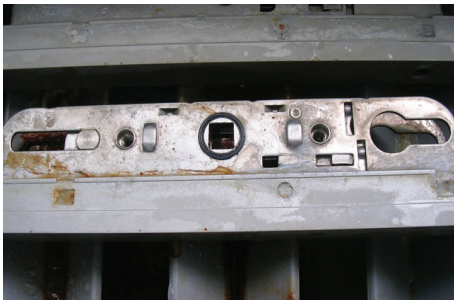
DRIVE GEAR

GEAR BOX	Minor corrosion
LINKAGE	SST Flat linkrod/Pin Fail-proof
AL SASH	No corrosion
OPERATION	No problem

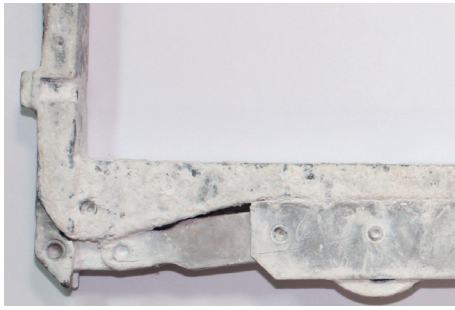
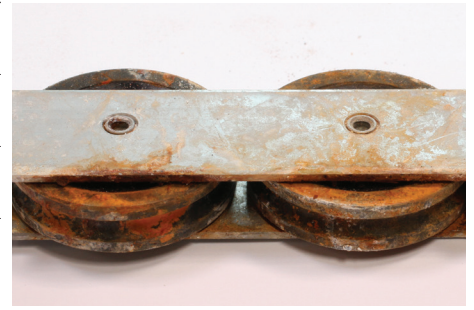
CARRIAGE (#97, 98, 94)

BODY	Plating is corroded. White rust is present.
BAR	Plating was corroded, Rust is present.
BEARING	Corrosion at 48 hours No longer functional
OPERATION	Cannot roll. Corroded plate is stuck between roller and housing.

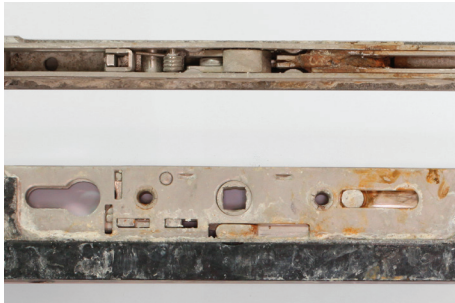
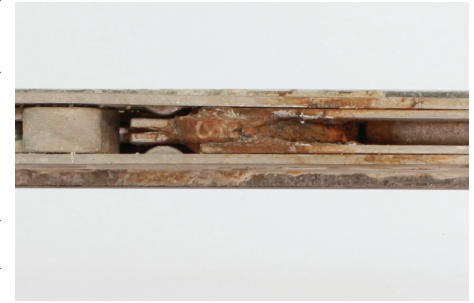
DRIVE GEAR (#95)

GEAR BOX	Plating is corroded. There is serious rust.
LINKAGE	Stainless Flat linkrod/Pin Grade unknown
AL SASH	Severe corrosion
OPERATION	Impossible

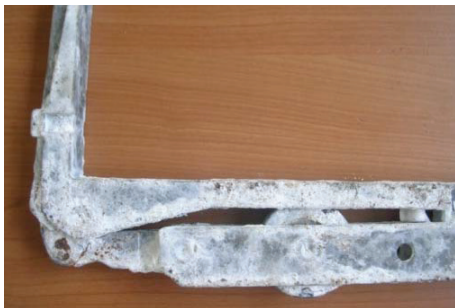
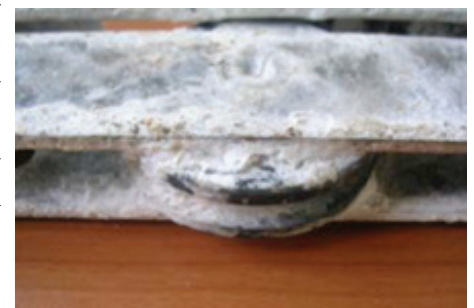
CARRIAGE (K-164 88-00-0-1)

BODY	Plating is corroded. White rust is present.
BAR	Plating was corroded, Rust is present.
BEARING	Corrosion,
OPERATION	Cannot roll. Corroded plate is stuck between roller and housing.

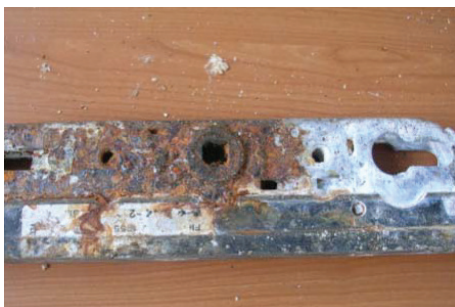
DRIVE GEAR

GEAR BOX	Plating is corroded. There is serious rust.
LINKAGE	Steel Cylindrical Rod with Set screw. Failure eminent
AL SASH	Severe corrosion
OPERATION	Impossible

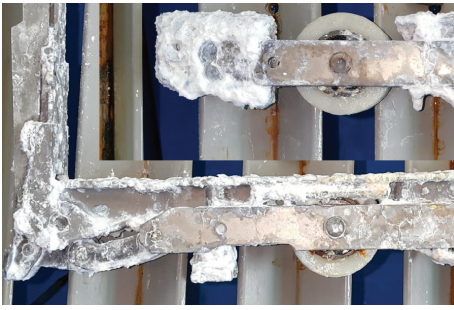
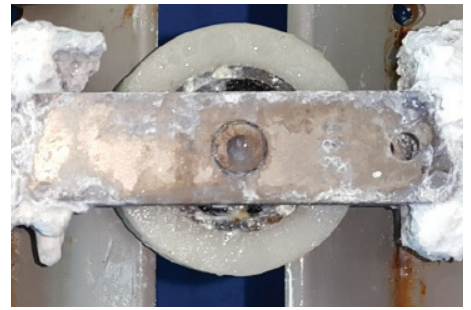
CARRIAGE (PEU B0030-10001, PLW B0040-10001)

BODY	Plating is corroded. White rust is present.
BAR	Plating was corroded, Rust is present.
BEARING	Corrosion,
OPERATION	Cannot roll. Corroded plate is stuck between roller and housing.

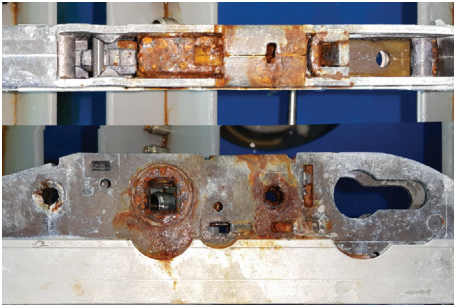
DRIVE GEAR (PGKB 4080-52401)

GEAR BOX	Plating is corroded. There is serious rust.
LINKAGE	Steel Flat linkrod/Pin Corrosion eminent
AL SASH	Severe corrosion
OPERATION	Impossible

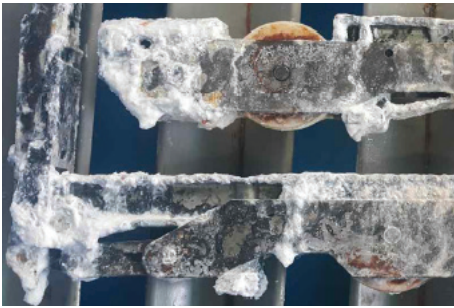
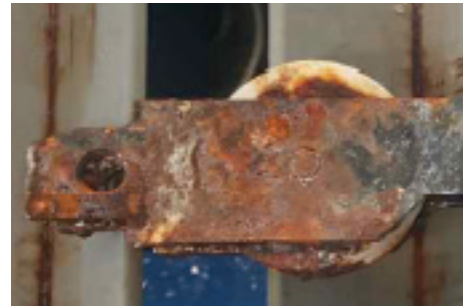
CARRIAGE (#184575)

BODY	Plating is corroded. White rust is present.
BAR	Plating was corroded, Rust is present.
BEARING	Corrosion,
OPERATION	Cannot roll. Corroded plate is stuck between roller and housing.

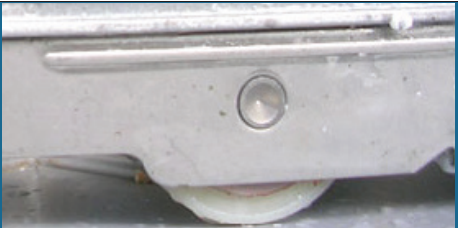
<p>BODY: Minor corrosion BAR: No corrosion BEARING: Minor corrosion OPERATION: No problem</p>
<p>FFI Stainless Steel 439 (430)</p>

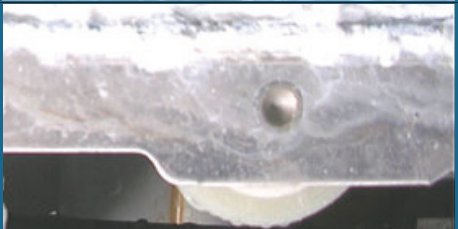
<p>BODY: Minor corrosion BAR: No corrosion BEARING: Minor corrosion OPERATION: No problem</p>
<p>FPL</p>

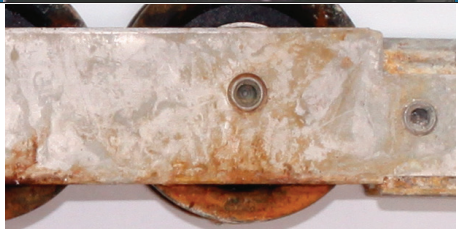
<p>BODY: Plating is corroded, serious white rust. BAR: Plating is corroded, rust is present. BEARING: Corrosion OPERATION: Cannot roll, plate is stuck between roller and housing.</p>
<p>G-U</p>

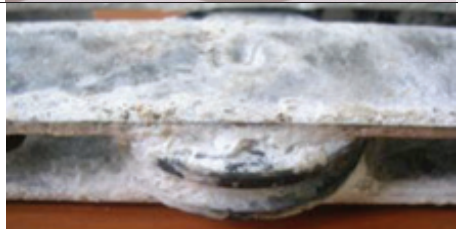
<p>BODY: Plating is corroded, serious white rust. BAR: Plating is corroded, rust is present. BEARING: Corrosion OPERATION: Cannot roll, plate is stuck between roller and housing.</p>
<p>Siegenia</p>

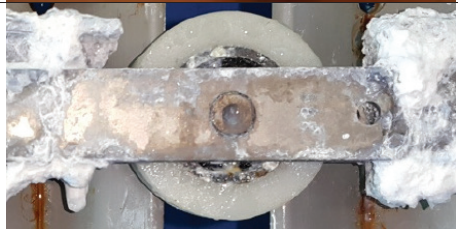
<p>BODY: Plating is corroded, serious white rust. BAR: Plating is corroded, rust is present. BEARING: Corrosion OPERATION: Cannot roll, plate is stuck between roller and housing.</p>
<p>Hautau (Distributed by Hoppe)</p>

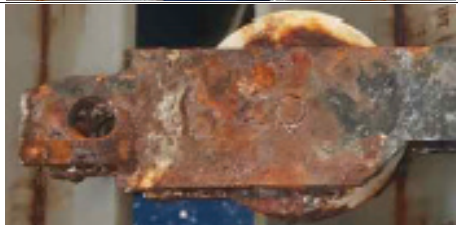
<p>BODY: Plating is corroded, serious white rust. BAR: Plating is corroded, rust is present. BEARING: Corrosion OPERATION: Cannot roll, plate is stuck between roller and housing.</p>
