FFI Stainless Steel Lift Slide Corrosion Resistance

Lift Slide Corrosion Report

1. Test Requested By: FUNCTIONAL FENESTRATION, INC.
2. Test Method: 5% Salt Spray for 3000 Hours
3. Test Standard: ASTM B-117
4. Test Agency: Korea Testing & Research Institute, By: D.H. Choi
5. Test Period: 2008.3.28 < 8.4 . Report Date: 2008.8.18 .
6. Product Name: LS Roller, Drive Gear (G-U, AGB, FFI. 1 Set / Each Company)
7. Results:

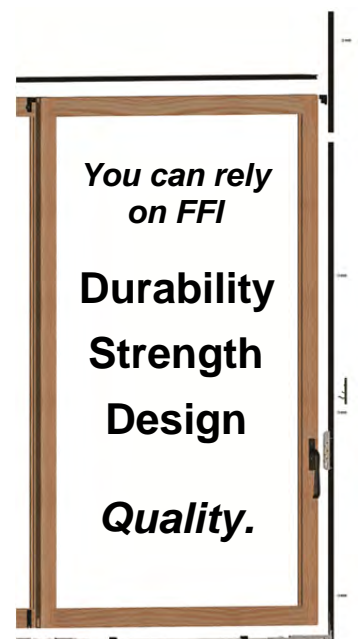
Salt-spray testing is performed to ASTM B-117 standards for 3,000 hours.

- ▶ Only FFI's Stainless Steel Lift Slide has a 15 Year Warranty against corrosion.
- ▶ FFI's Lift Slide is available in 2 grades of Stainless Steel with superior corrosion resistance.

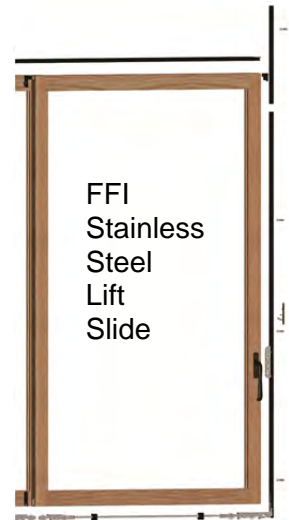
Item		Company			
		G-U	AGB	FFI (304)	FFI (439/430 *)
CORNER DRIVE CARRIAGE	Rust Condition	Whole carriage corroded	Whole carriage corroded	Minor surface corrosion	Some surface corrosion
	Operating Condition	Cannot operate	Cannot operate	Good	Good
DRIVE GEAR LOCK	Rust Condition	Whole gear corroded	Whole gear corroded	Minor surface corrosion	Some surface corrosion
	Operating Condition	Cannot operate	Cannot operate	Good	Good

Small amounts of corrosion, however general condition of product is good.
Corrosion is not causing problems to operation and function.

Whole product was contaminated by corrosion and rust.
Corrosion caused critical problems for function; product was impossible to operate.

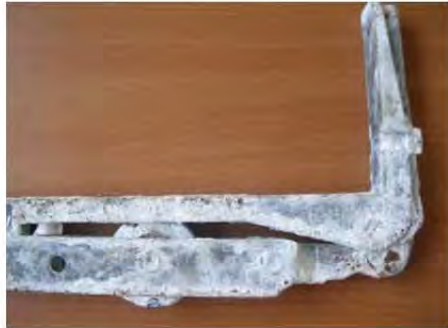
Item : CORNER DRIVE

- 1) BODY : Plating was corroded, There is serious white rust.
- 2) BAR : Plating was corroded, There is rust.
- 3) BEARING : Corrosion
- 4) OPERATION : cannot roll because corroded plate is stuck between roller and housing

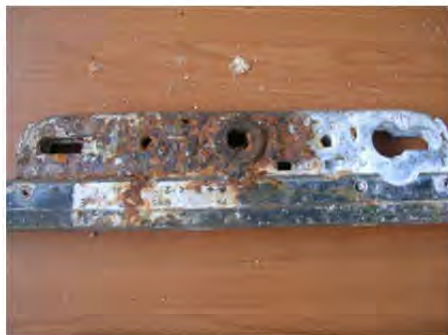
item : DRIVE GEAR

- 1) GEARBOX : Plating was corroded, there is serious rust.
- 2) AL SASH : Severe corrosion
- 3) OPERATION : Impossible

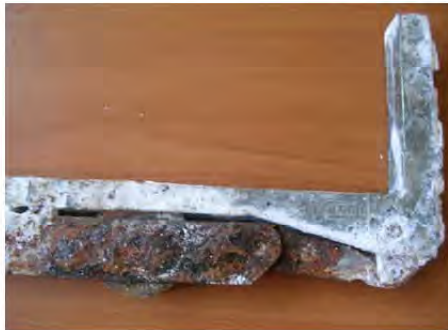
Item : CORNER DRIVE

- 1) BODY : Plating was corroded, there is serious white rust.
- 2) BAR : Plating was corroded, there is rust.
- 3) BEARING : Corrosion
- 4) OPERATION : cannot roll because corroded plate is stuck between roller and housing

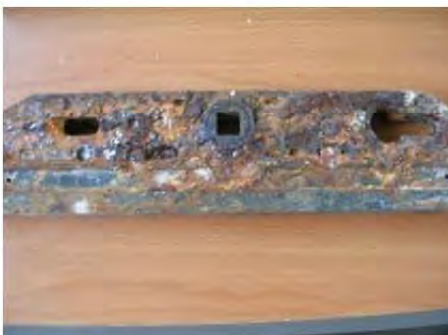
Item : DRIVE GEAR

- 1) GEARBOX : Plating was corroded, there is serious rust.
- 2) AL SASH : Severe corrosion
- 3) OPERATION : Impossible

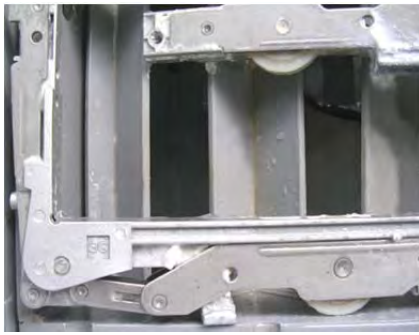
Item : CORNER DRIVE

- 1) BODY : Minute corrosion
- 2) BAR : No corrosion
- 3) BEARING : Minute corrosion
- 4) OPERATION : No problem

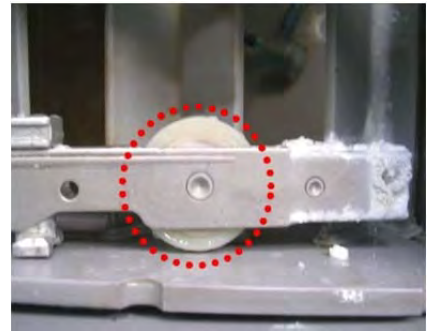
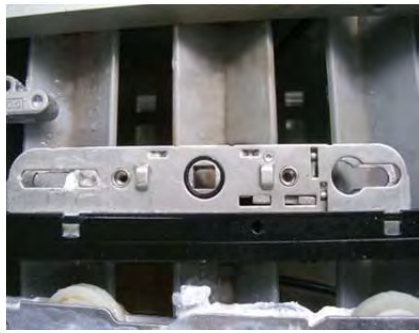
Item : DRIVE GEAR

- 1) GEARBOX : Minute corrosion
- 2) AL SASH : No corrosion
- 3) OPERATION : No problem

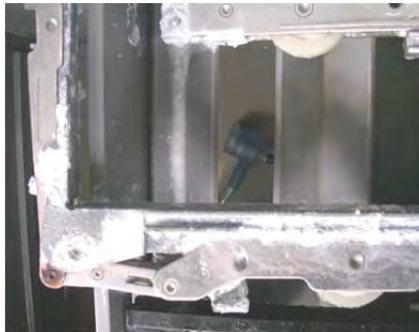
Item : CORNER DRIVE

- 1) BODY : Some corrosion
- 2) BAR : Minute corrosion
- 3) BEARING : Some corrosion
- 4) OPERATION : No problem

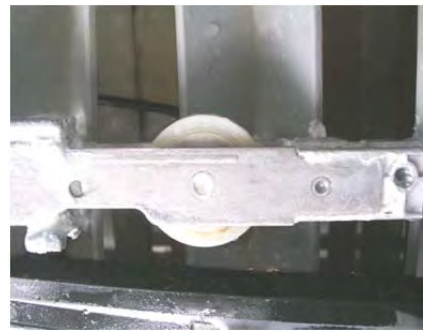
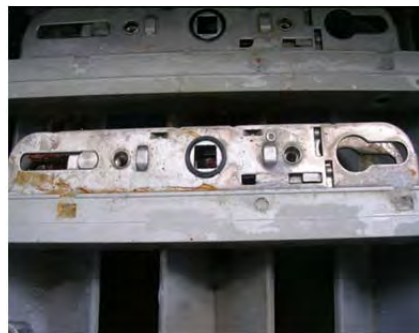
Item : DRIVE GEAR

- 1) GEARBOX : Some corrosion
- 2) AL SASH : Some corrosion
- 3) OPERATION : No problem
