## Test Report

Report No. : 2016-TBC-70  
Customer : 3G Technologies Co., Ltd.  
Representative : Lee, Sang Do  
Address : #410-1 Ssangjung-ri, Eumseong-Gun,  
Chung Buk, Korea.  
Sample Name : Lift Sliding System Hardware 400V

1. Sample Name : Lift Sliding System Hardware 400V

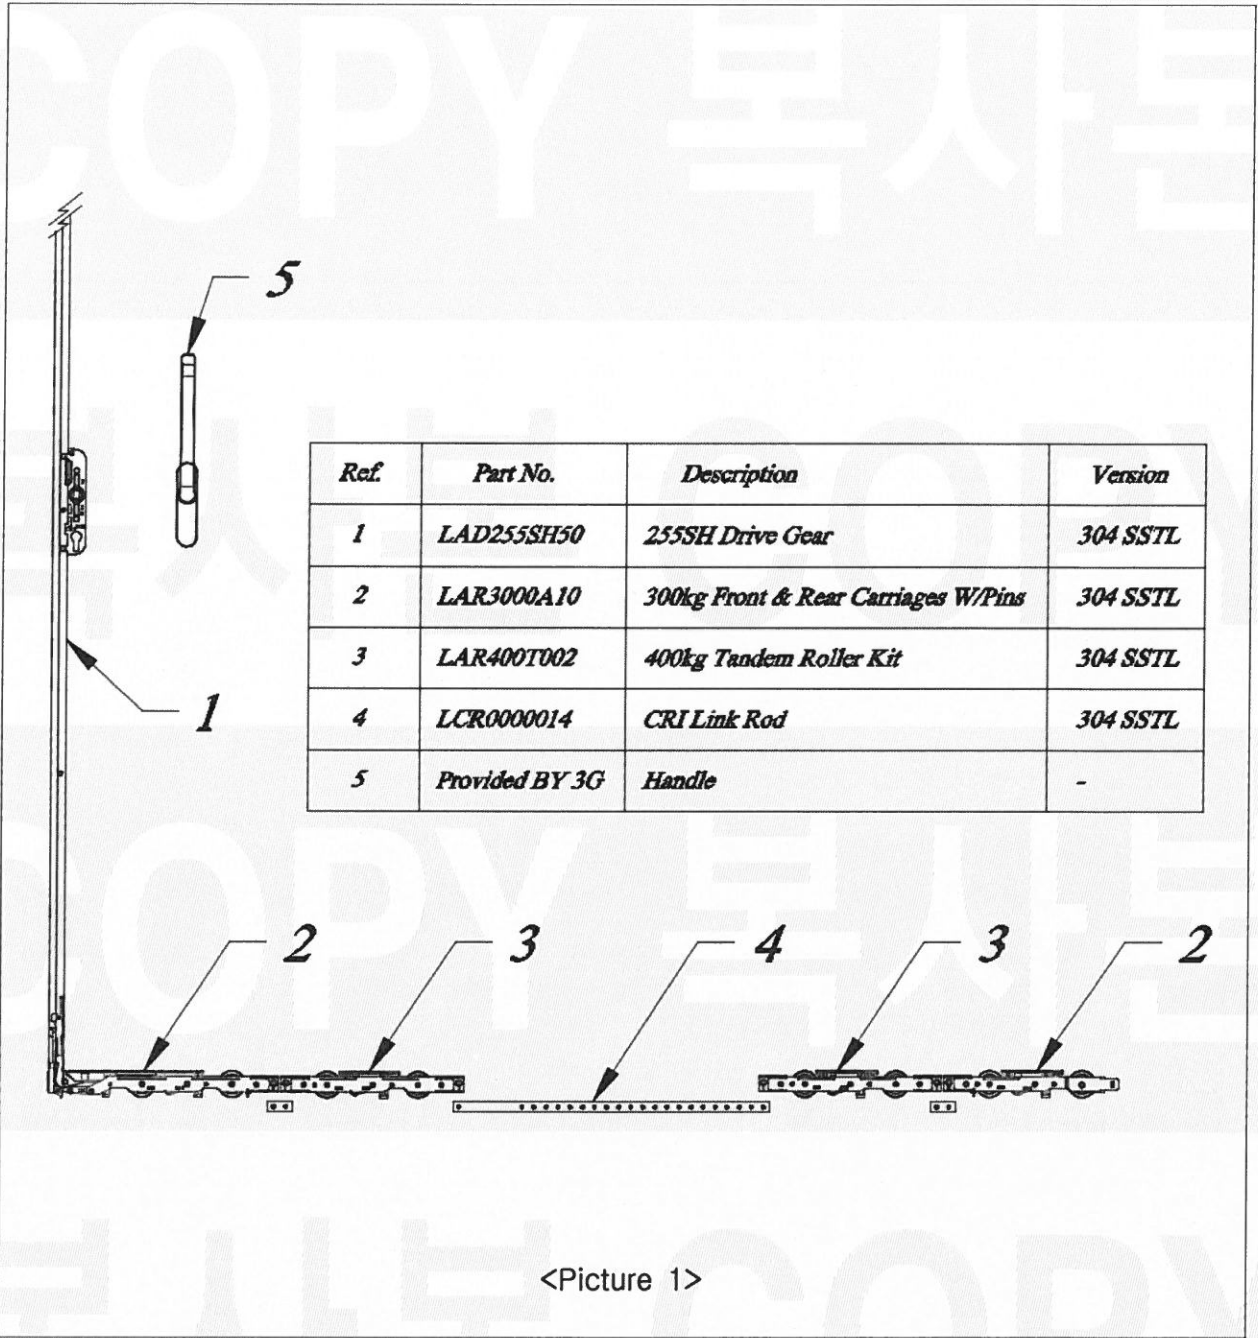
<Picture 1>

4. Structure of Goods : The specific structure of the used sample for this test was  
same as picture #1.

- Max. Application size
  1. Height : 3,100 mm
  2. Width : 6,000 mm
- Min. Application size
  1. Height : 1,000 mm
  2. Width : 1,320 mm
- Max. Application weight : 400 kg(3,920 N)

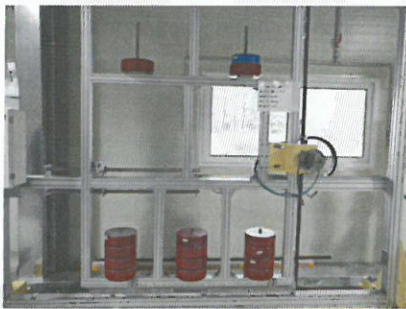
1. Window driving

5.3.1 Driving test is performed with using the durability tester of clause 5.1 in accordance with the test condition of clause 5.2. to do the drive back & force for 100,000 times. (ref. Picture #3)

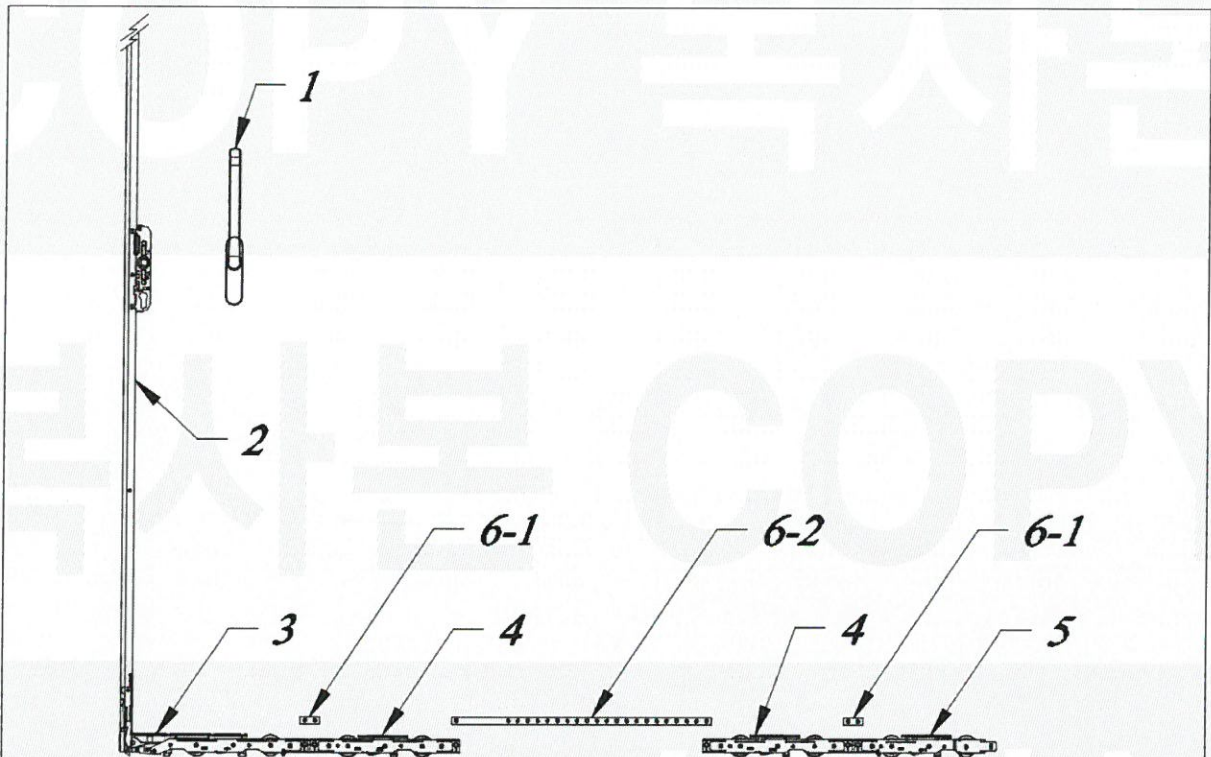
<Picture 4>

5.3.2 After completion of driving test for 100,000 times, according to the particular parts criterion of clause 5.4, the operation and exterior condition will be confirmed by physical eye inspection. (ref. Picture #4)

No	Parts	Test clause	Criterion
1	Handle	Operation	Estimate no defect
		Appearance	Estimate no damage
2	Drive gear	Operation	Estimate no defect
		Appearance	Estimate no damage
3	Front Corner Drive	Operation	Estimate no defect
		Appearance	Estimate no damage
4	Tandem bogie	Operation	Estimate no defect
		Appearance	Estimate no damage
5	Rear bogie	Operation	Estimate no defect
		Appearance	Estimate no damage
6-1	Link plate	Appearance	Estimate no transform
6-2	Connecting rod	Appearance	Estimate no transform
